PROBLEMS, CAUSES, AND CURES

Technical Publication No. C200 • Revised © 2018 | 3rd Edition

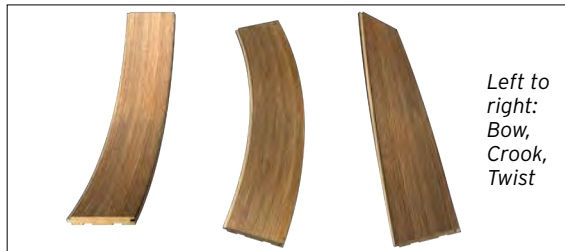
Bow - A deviation in the lengthwise flatness of a board, measured end to end.

- Solid wood flooring: Bow occurs when one side of the floor board shrinks more in length than the other. It causes the lengthwise curvature of the plank that resembles a bow used in archery. Because longitudinal shrinkage in solid wood is minimal, bow is normally not an issue that affects installation.
- Engineered wood flooring: Bow occurs when the wear layer and the core begin to shrink in opposing lengthwise directions, forcing the uninstalled planks to bow. Manufacturer and industry standards (HPVA) dictate tolerances and milling requirements for the amount of bow allowed in an engineered wood floor at the time of manufacture. This may or may not coincide with uninstalled flooring at the jobsite due to change in moisture content as a result of jobsite conditions.

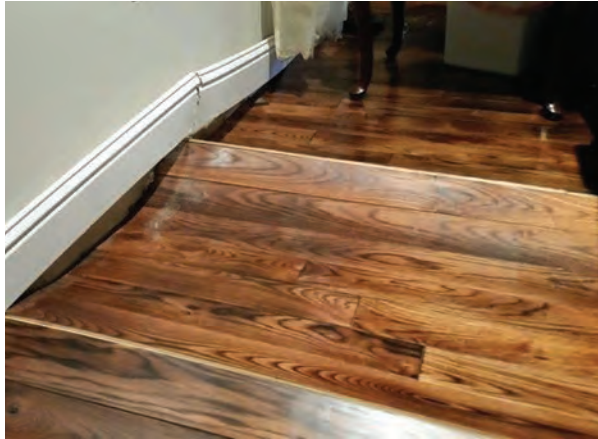
Buckling

DEFINITION: The wood flooring has separated or lifted from the subfloor.

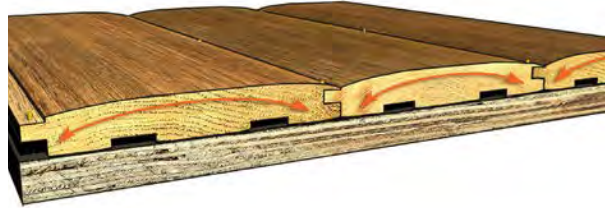
Crowning

DEFINITION: A convex or crowned appearance of individual boards with the center of the board higher than the edges. This can also be a type of warp.

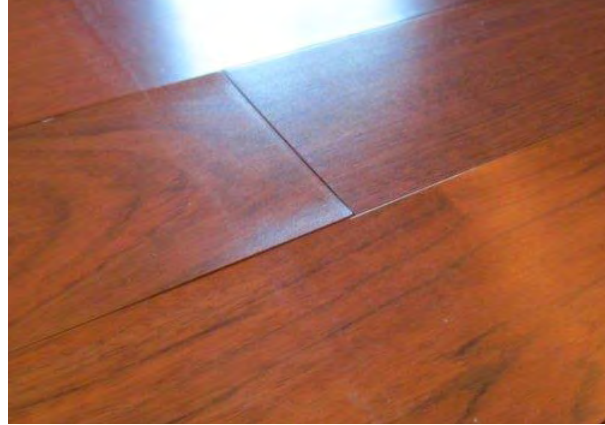
Dry Cupping

DEFINITION: A concave or dished appearance of individual engineered flooring planks with the edges raised higher than the center.

- When relative humidity levels remain below the manufacturer's recommendations for long enough, engineered planks can begin to dry cup. When this happens, the wear layer loses moisture and begins to shrink across its outer face, which can exert enough force on the core material to pull the edges of the plank (often the groove side) upward. This causes a cupped appearance across the width of the board.

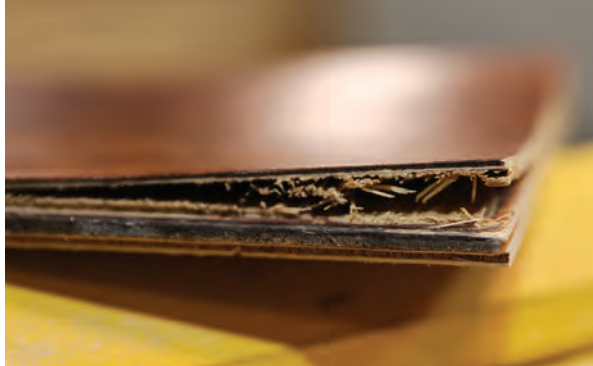
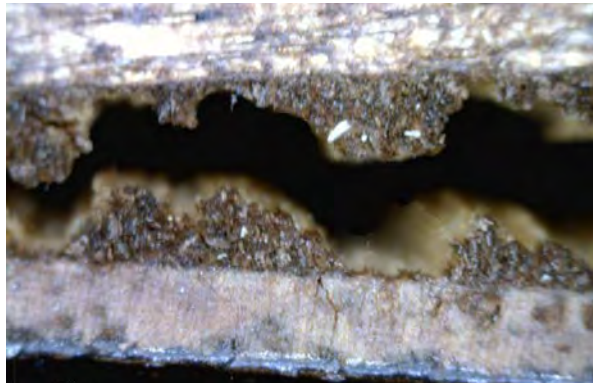
Wood Shear (Engineered Flooring)

DEFINITION: External stresses exceeding the strength of the wood fibers within an individual plank of engineered flooring, resulting in the wood fibers being torn apart. When examining this type of failure in an engineered wood flooring plank, wood fibers will be visible at the point of separation, remaining bonded to the adhesive layer.

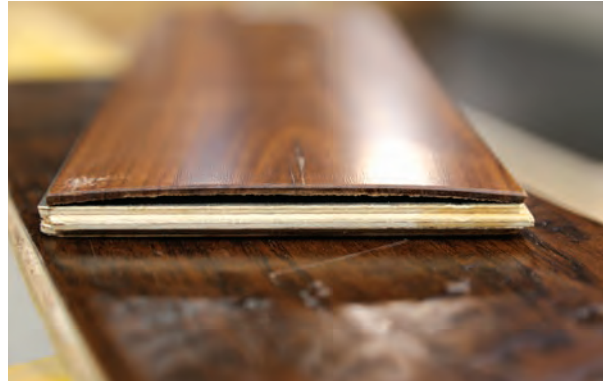
Delamination/ Glue-Line Separation (Engineered Flooring)

DEFINITION: Engineered flooring is manufactured by adhering several layers/plies together. The separation of two layers/plies within a piece of engineered flooring due to the lack of an adhesive bond is typically identified as a clean separation at the glue-line. Adhesive bond failure is unrelated to inadequate relative humidity levels.

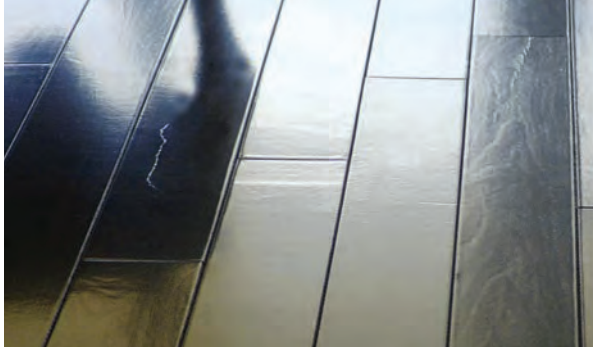
Telegraphing Core Material (Engineered Flooring)

DEFINITION: Visible patterns on the surface of the wood floor plank that resembles variations in the engineered flooring core material.

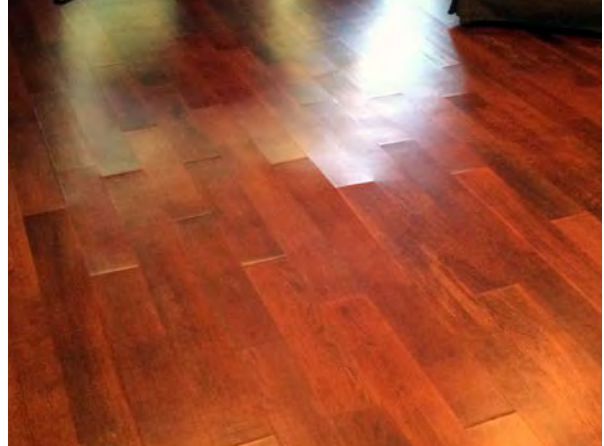
Endlift/Ski (Engineered Flooring)

DEFINITION: A condition where the ends of installed engineered wood flooring boards deviate from the flat plane and appear raised or curved upward.

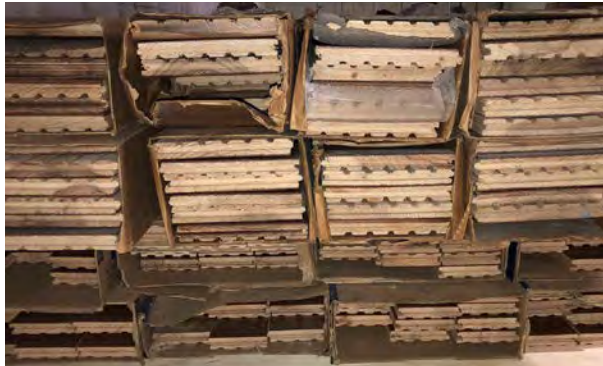
End-Swell/Flared-Ends (Solid Flooring)

DEFINITION: A condition where the ends of solid wood flooring boards deviate from the flat plane and/or parallel plane, and may appear wider or thicker than the rest of the board.

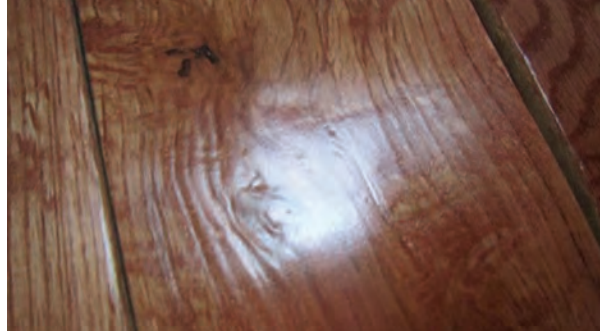
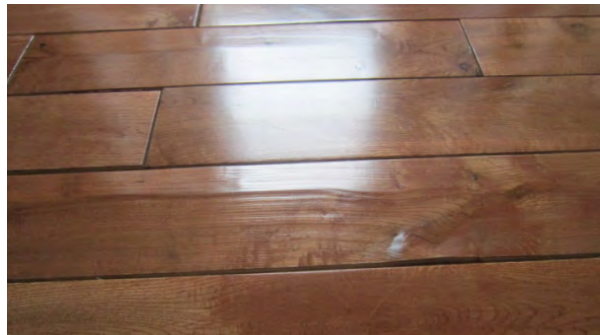
Reaction or Juvenile Wood

DEFINITION: Natural and unique features, properties, and growth patterns in wood that cause it to appear and perform non-traditionally, resulting in distortions from non-uniform swelling and shrinking.

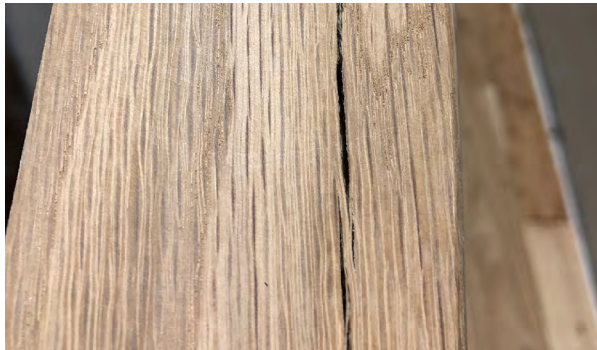
Surface-Checks - Surface checks are separations in the wood fibers that usually occur in, or adjacent to, the wood rays on the faces of plainsawn (flatsawn) boards. These separations occur during the early phases of the drying process where the external and internal stresses cause the wood to tear itself apart.

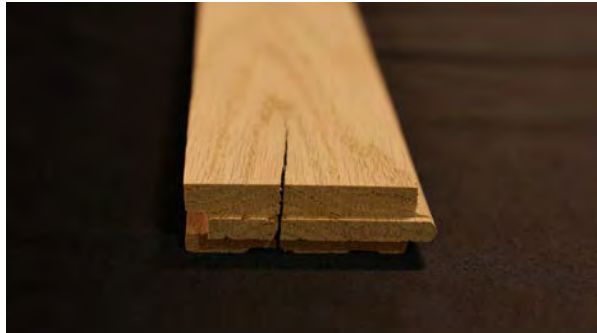
End-Checks - Like surface checks, end checks occur in, or adjacent to, the wood rays, but on the ends of the boards rather than the face. These separations occur due to the normal movement of moisture along the length of the boards, where the ends of the boards dry more rapidly leading to stress fractures on the ends of the boards.

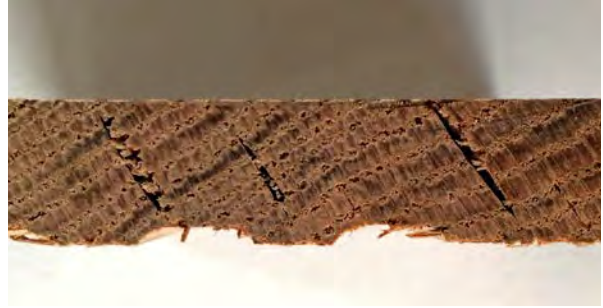
Internal Checks (Honeycomb) - An internal defect in the wood that may not be visible on the surface of the board, but occurs in the core (inner part of the board) of solid boards. These checks can become exposed when the boards are sanded or milled. They can also become exposed on the surface of the board with a loss in moisture or changes in RH after installation.

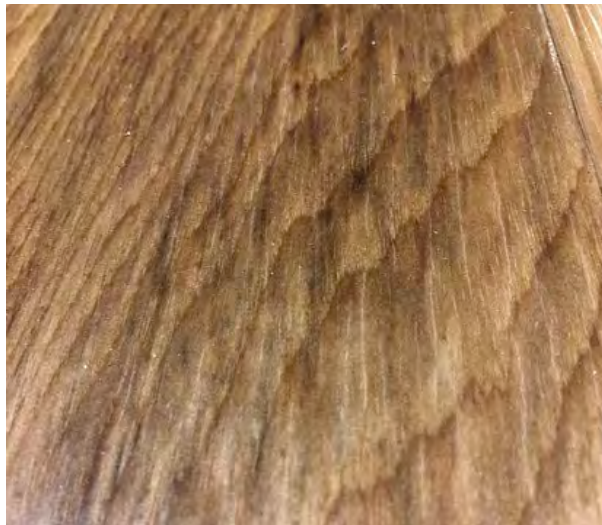
Lathe Checks (Rotary Peeled/Sliced Engineered Flooring)

DEFINITION: In engineered flooring with rotary peeled or sliced face veneers, as the knife separates the veneer from the log, the separated sheet of wood is laid flat where stresses can occur in the region near the knife edge. If the strength of the wood is exceeded, this stress is relieved by separations (or checks) of the wood fibers parallel to the grain of the veneer at the knife edge. The knife edge of the veneer is known as the open (or loose) side, and the opposite side of the veneer is known as the closed (or tight) side. Lathe checks are not normally visible on the face of the finished board.

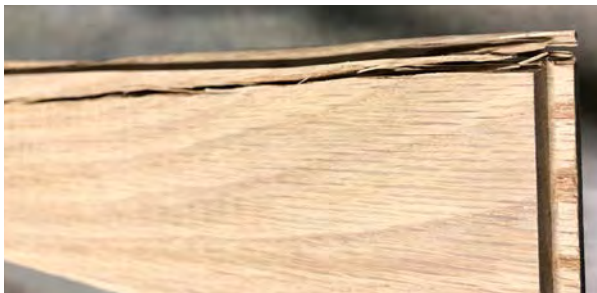
Splits/Cracks

DEFINITION: A tearing apart or rupturing of the wood that may run at various angles to the growth rings.

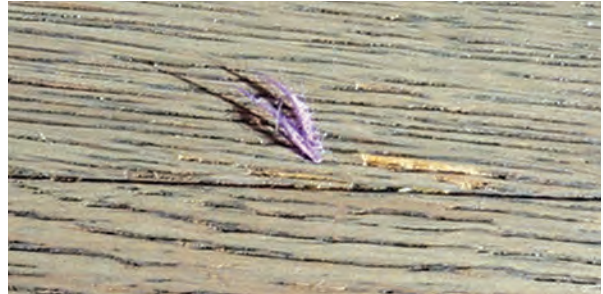
Slivers/Splinters

DEFINITION: Sharp fragment of wood separated/fractured away from the edge or face of the board protruding from the floor.

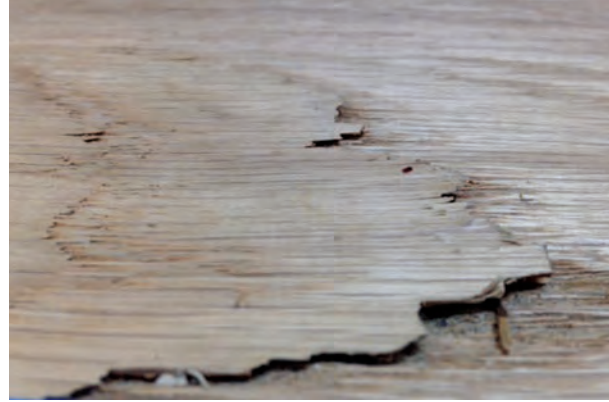
Shake (Ring Shake/Ruptured Grain)

DEFINITION: A separation of the wood's fibers along the grain (parallel to the growth rings), that usually occurs between the rings of annual growth.

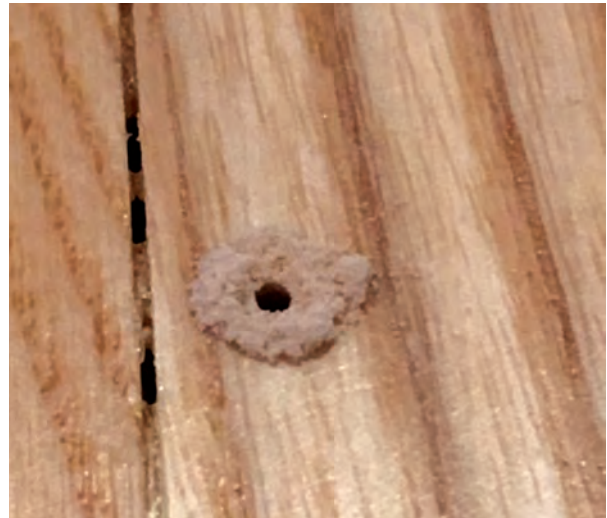
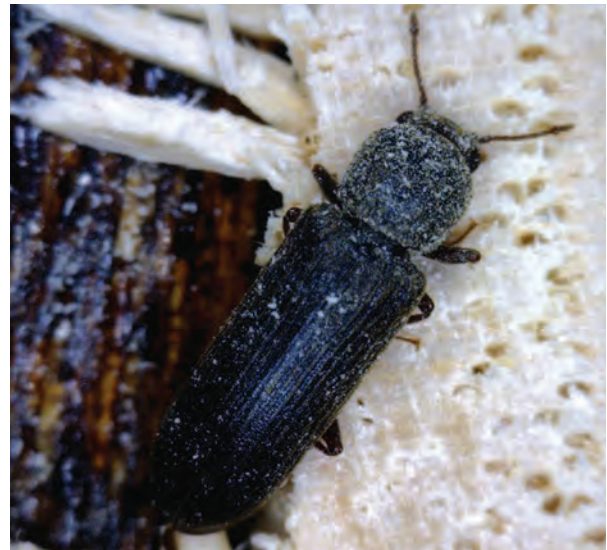
- **Powderpost (Lyctid/Anobiid) Beetle** - The larvae of wood-eating insects bore in and feed on the wood fibers causing damage to both hardwoods and softwoods. Properly kiln-dried lumber will normally eliminate powderpost beetles, but infestations can occur at any point after the kiln-drying process, including during storage, transport, or from other wood products.

- Infestation often occurs long before, but can even occur after the wood floor is installed. Female beetles lay their eggs within the pores of the bare, unfinished wood. The larvae feed on the wood, creating tunnels that fill with a powdery substance called frass. Later, when the larvae mature, they exit the wood, creating small pinholes, generally measuring 1mm-3mm (1/16"). In active infestations, the holes will be surrounded by this frass (light-colored powder). This frass material is very fine and will feel like talcum powder when rubbed between two fingers. The presence of an actual beetle, beetle larvae, or frass is the only way to absolutely confirm an active infestation.

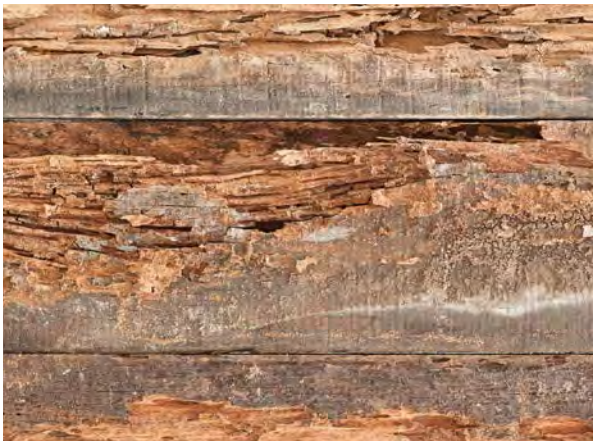
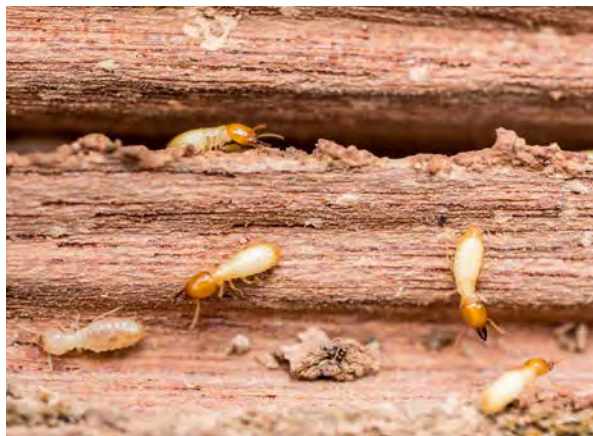
- **Termites** - Termites are attracted to areas where moisture accumulates in and around your home, including damp basements, laundry rooms, bathrooms, and leaky foundation walls.
 - Termites will eat any kind of wood including mulch, rotting wood, new wood, painted wood, and treated wood.
 - Stagnant, moist air in the home provides the perfect breeding ground for termites.
 - Termite-damaged wood is usually hollowed out along the grain, with bits of dried mud or soil lining the feeding galleries. Wood damaged by moisture or other types of insects will not have this appearance.
 - Termite infestations are a site-specific condition.

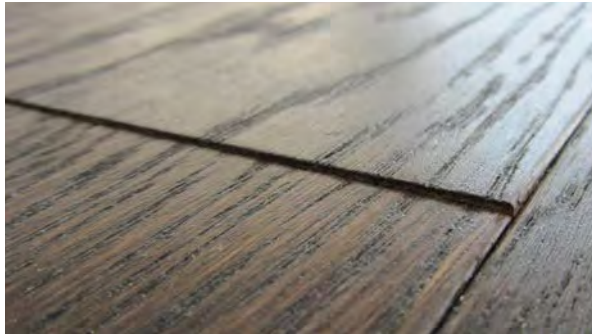
Overwood/Underwood

DEFINITION: A vertical offset that exists between two adjoining installed floorboards.

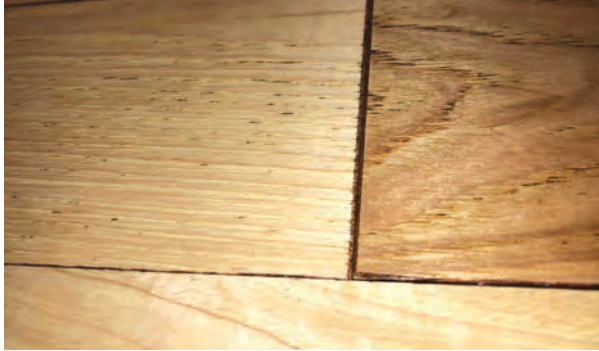
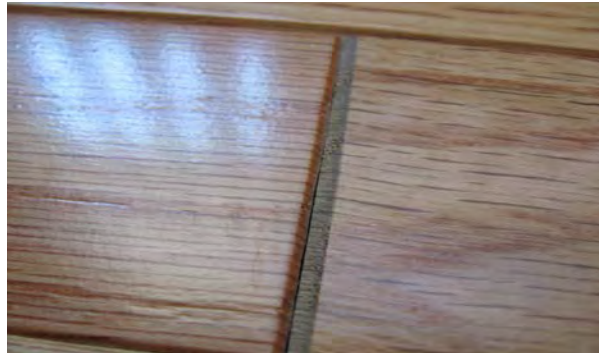
Uneven Bevels

DEFINITION: Bevels within an installed or uninstalled wood floor appear inconsistent in width, depth, shape, profile, or size.

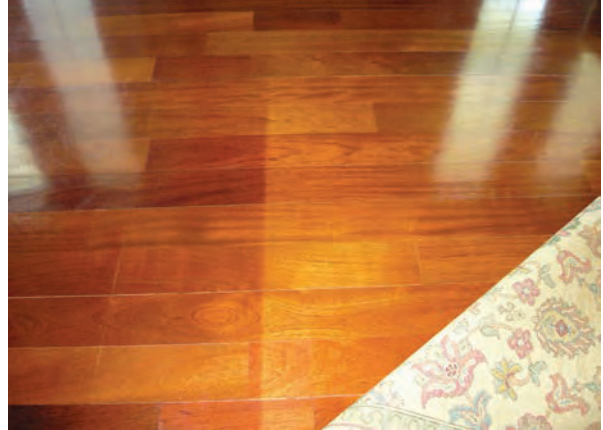
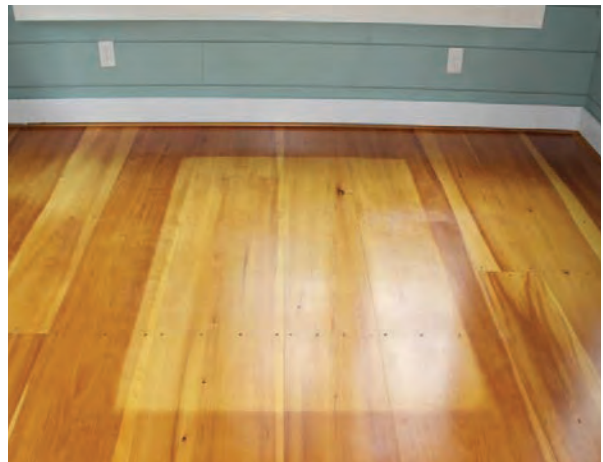
Wood Discoloration

DEFINITION: The wood itself changes color over time (darkens or lightens).

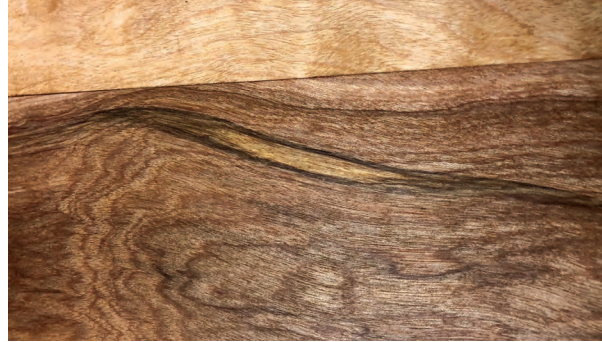
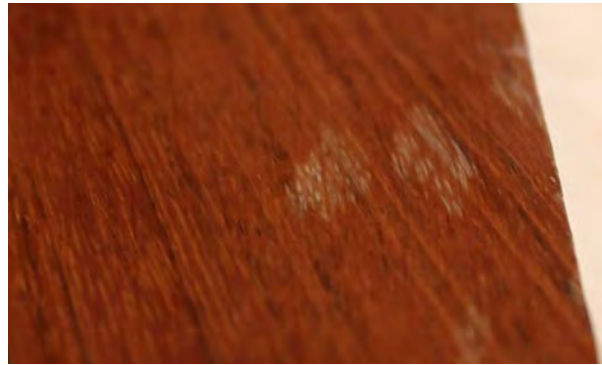
Mineral Streaks/Deposits

DEFINITION: A discolored line, spot, or band in the wood that may range in color from light gray to tan, olive green, brown, purple, blue, or black. Mineral streaks/deposits are naturally occurring and they are often considered to add value and appeal to the wood.

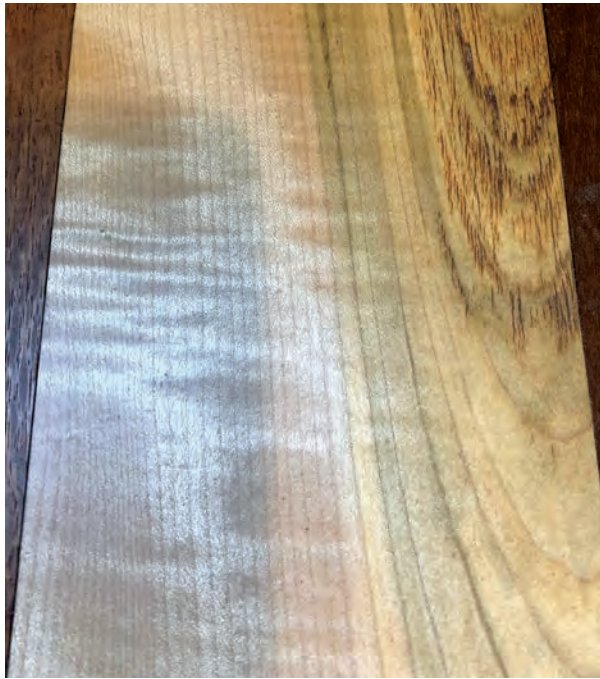
Sap Stains (Blue-Stain or Brown-Stain)

DEFINITION: A discoloration in the sapwood. Sapwood itself is the active wood near the outside of the living tree. It is often lighter in color than the heartwood of the tree. Sapwood color variation is normal and acceptable in all grades, and must not be confused with sap stain.

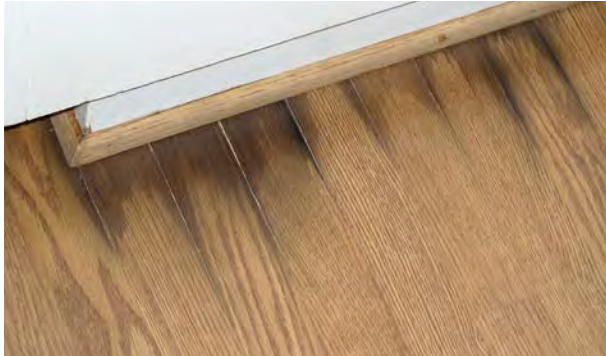
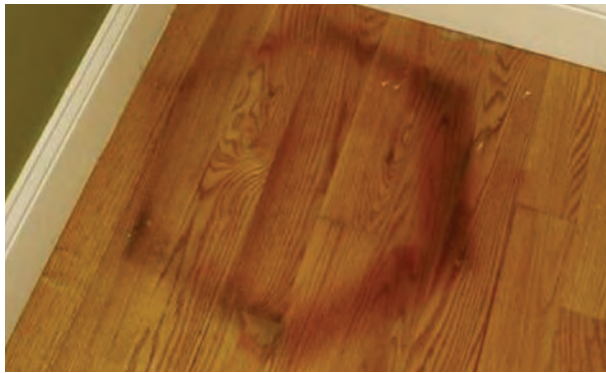
Moisture Stains

DEFINITION: The wood or finish changes color with exposure to moisture.

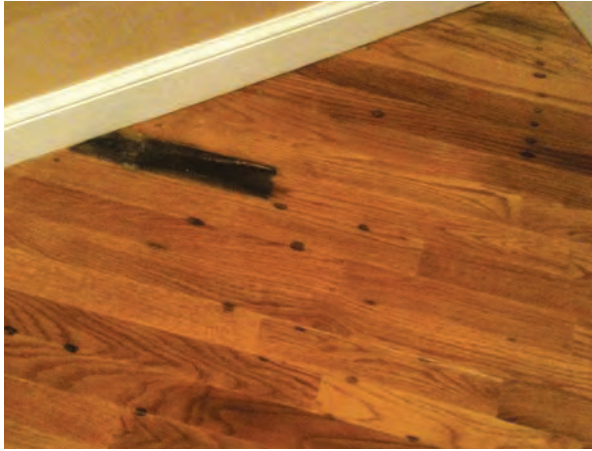
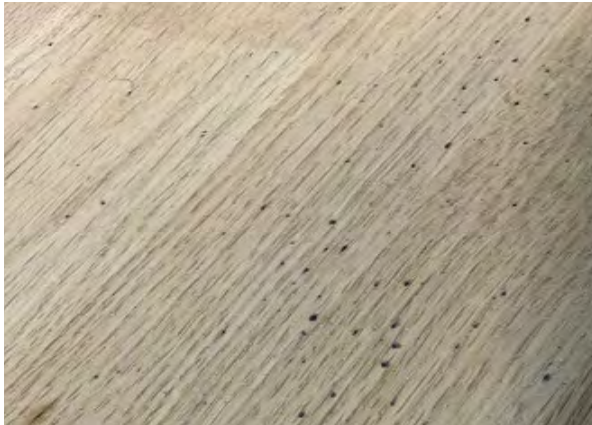
Iron Stains

DEFINITION: A result of a chemical reaction between wood tannins, water, and iron.

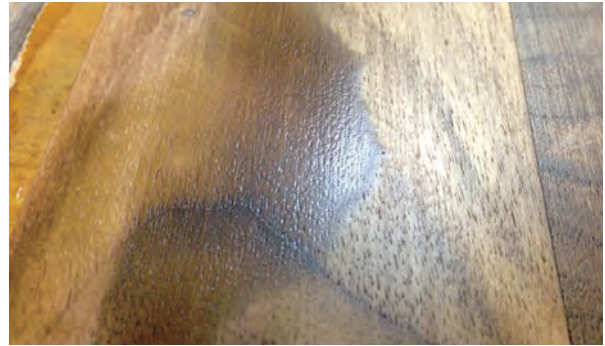
Tannic Acid Discoloration/ Tannin-Pull

DEFINITION: Tannic acid includes various naturally occurring soluble astringent complex phenolic substances found in trees (and plants) as a way of protecting the tree from insects, fire, and bacteria. High levels of tannic acid present in woods like oak, walnut, and mahogany can produce a dark discoloration when coming in contact with some products used in the finishing and maintenance of wood floors.

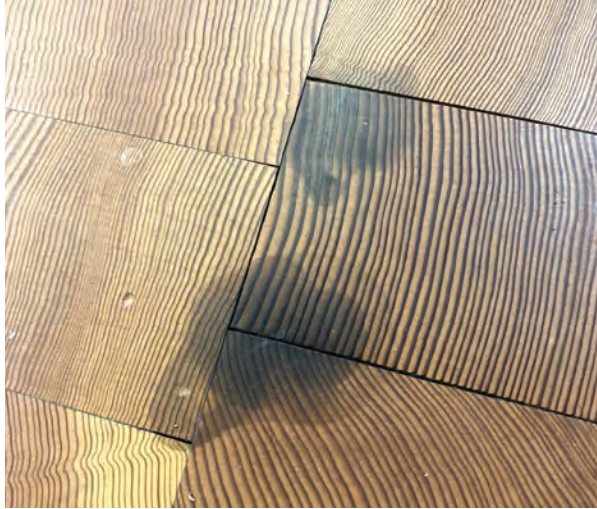
Chemical Stains

DEFINITION: Irregular shaped spots or discolorations on areas of the finished floor caused by reactive chemicals and/or air pollution.

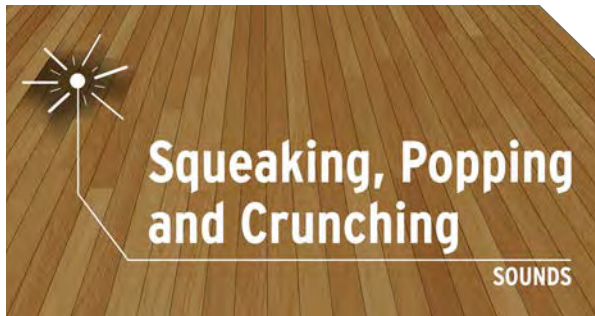
Squeaking/Popping/ Crunching Sounds

DEFINITION: Audible squeaking, popping, or crunching noises in an installed wood floor or within the floor system. Squeaks are not a direct concern with the installed wood floor as long as movement accompanying the audible squeak does not affect the performance of the installation. An occasional squeak within any properly installed wood floor system is not abnormal.

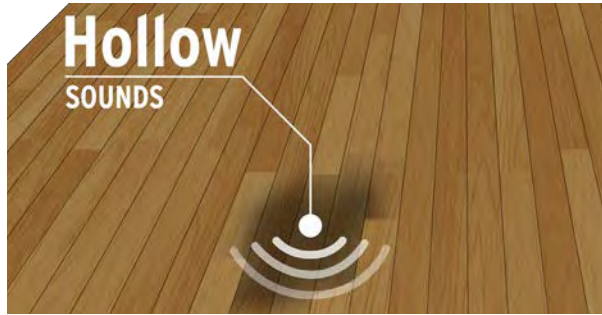
Hollow Sounds

DEFINITION: An audible hollow sound in the installed wood flooring. When no deflection is present, this may be considered normal with many installation methods provided that the installation followed proper installation procedures. Hollow sounds are not a direct concern with the performance of an installed wood floor as long as there is not movement accompanying the audible hollow sound.

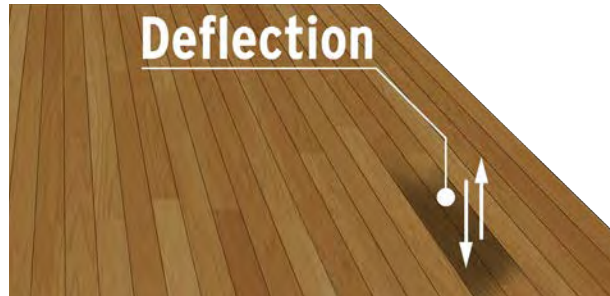
Deflection

DEFINITION: Isolated areas in an installed floor system that exhibit vertical (up and down) movement when pressure is applied.

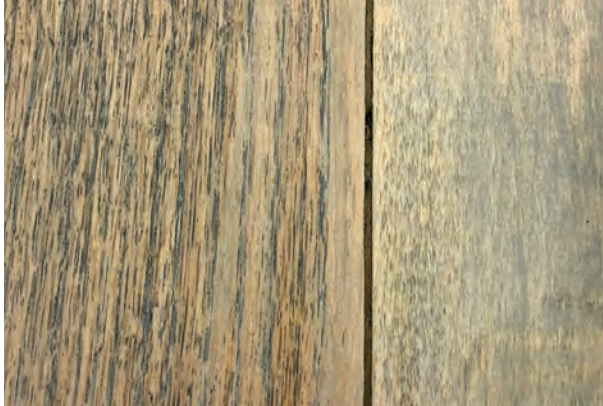
Seasonal/Normal Gaps

DEFINITION: Gaps that appear between individual boards, opening and closing with seasonal humidity changes. Wider boards can experience wider gaps. Gap size is directly related and proportional to the board width.

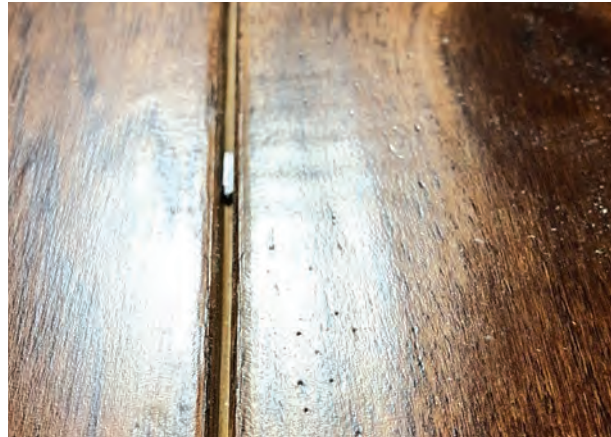
Abnormal Gaps

DEFINITION: Gaps between abutting wood floor boards in the installed floor that were not intentionally placed and remain with seasonal fluctuations in moisture and humidity.

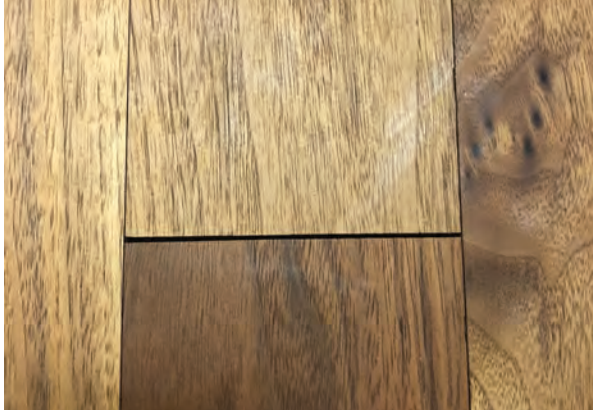
End-Gaps

DEFINITION: A separation that occurs on the ends of two abutting wood floor boards.

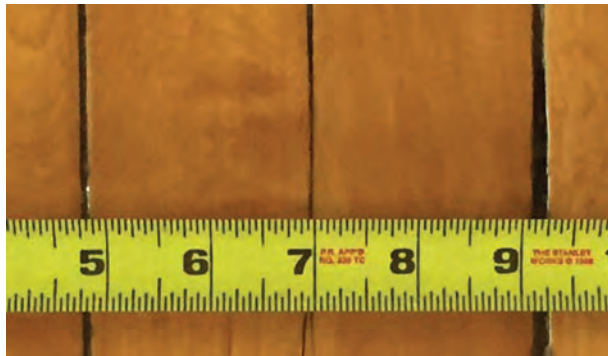
Compression-Set

DEFINITION: A generally uniform appearance of gaps between wood floor boards that directly coincides with the narrowing/crushing of individual board edges as a result of permanent cellular damage. The appearance of a compression-set floor may be similar to gaps from other causes, such as flooring that was milled and installed with high moisture content. When they are at the same moisture content at which they were milled, compression-set boards will be narrower than the milled width and may exhibit slightly raised edges along the board edges.

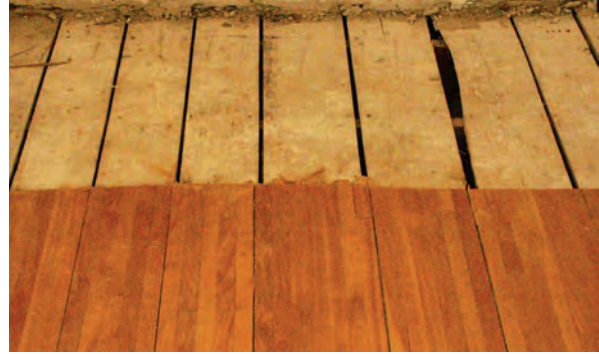
Panelization

DEFINITION: A generally uniform appearance of gaps or peaks in the surfaces of the wood floor that directly coincide with movement in the subfloor material beneath it.

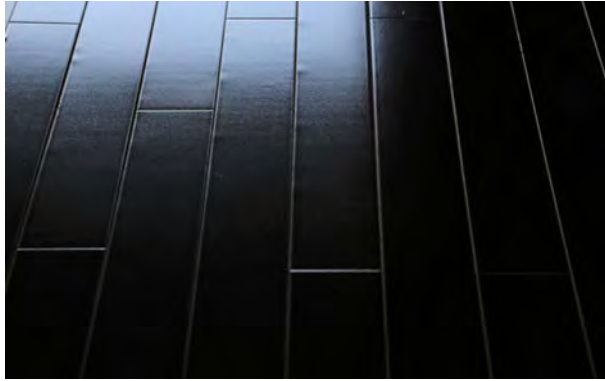
Telegraphing Fastener/Dimpling

DEFINITION: Dimples or bumps along the nailing surface of the finished flooring, directly related to fastener location and/or installation method.

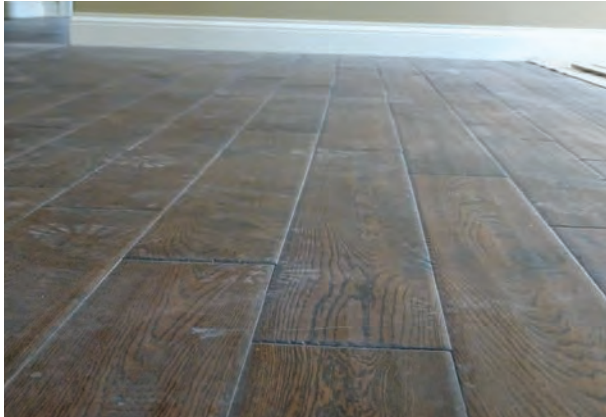
Crooked Installation Discrepancies

DEFINITION: An installed wood floor appearing bowed or out-of-square within the room in which it is installed. No wood floor installation is perfectly straight, parallel, or perpendicular to walls or fixtures. When the straightness of the installed floor takes away from the overall appearance of the floor within the structure, an aesthetic remedy may be necessary. The performance and structural integrity of the wood floor is not normally affected with any floor that has been installed out-of-square or out-of-a-straight-line.

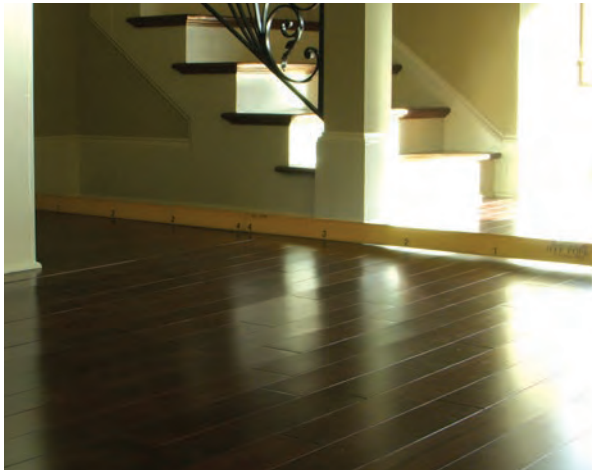
DEFINITION: The installed wood floor system appears to be uneven, wavy, or out of flat. Wood floors may be installed over out-of-level subfloors, but should fall within NWFA floor flatness tolerances. Subfloor flatness cannot be quantifiably measured when a floor covering is in place over it (without potentially extensive destructive testing), however, may give a good indication of what is happening below.

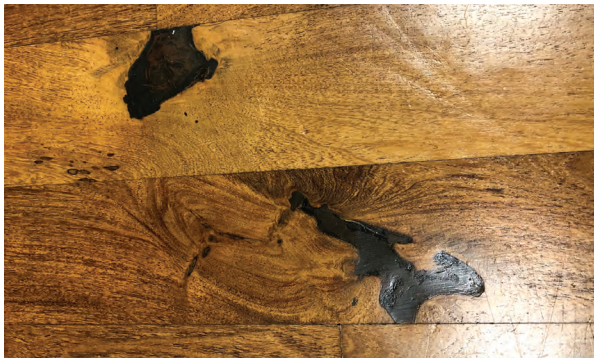
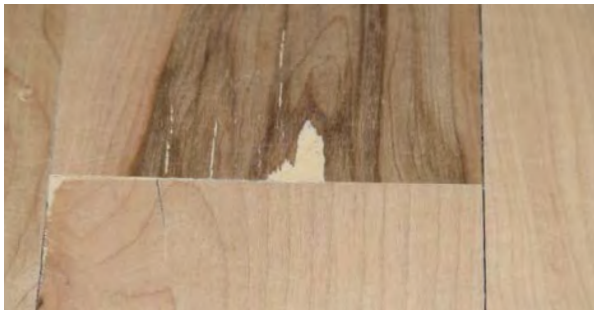
Filler Color Variation

DEFINITION: The wood filler from one area of the floor is different from the overall color tone of the floor. No two trees from the same species are identical, no two boards from the same tree are identical, and color and grain patterns can vary even within one individual plank of wood. Wood filler will never perfectly match, nor is it designed to match every board within a wood floor.

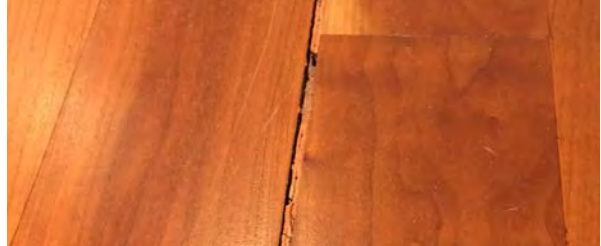
Popped Filler

DEFINITION: Wood floor filler that has become loose or no longer fills the void it was once in.

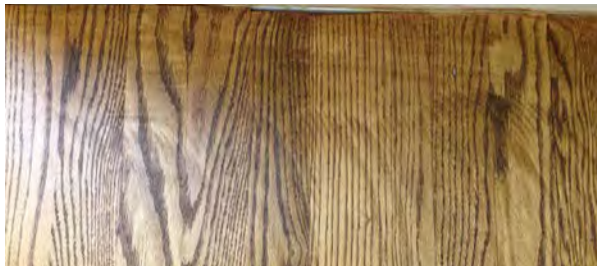
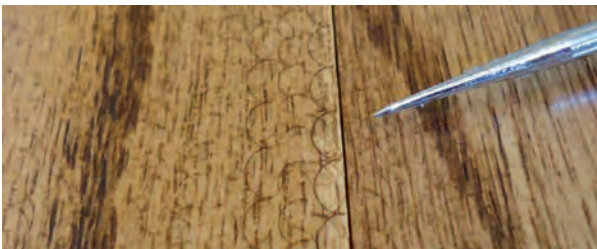
Sanding Marks

DEFINITION: Sanding imperfections seen as drum marks, side cuts, sanding scratches, or swirl marks. Sanding marks should be viewed from a standing position on the floor being assessed, in ambient lighting conditions. Glare from a direct light source must not be used during evaluation. Inspection may take place from floor level and/or with assistance of magnification in order to determine causes of irregularities, but not to determine acceptability.

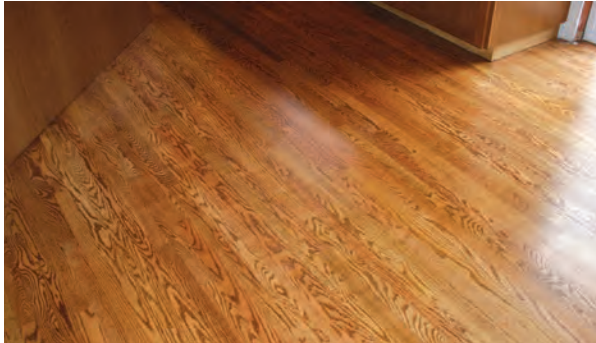
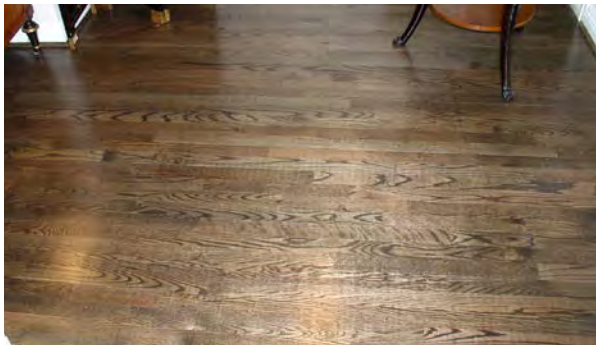
Chatter

DEFINITION: Slight unintentional indentations causing a ripple-like wave effects or “bars” that run perpendicular to the wood’s grain direction on the surface of a wood floor which can become visibly pronounced in direct lighting. The width of these “bars” can range from just a few millimeters to nearly an inch from peak to peak, and can occur in limited regions or can span the entire floor.

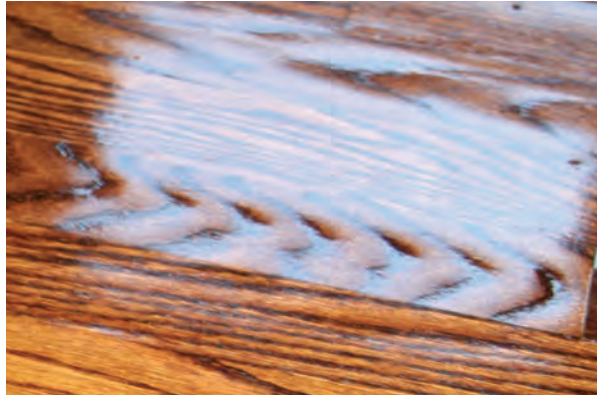
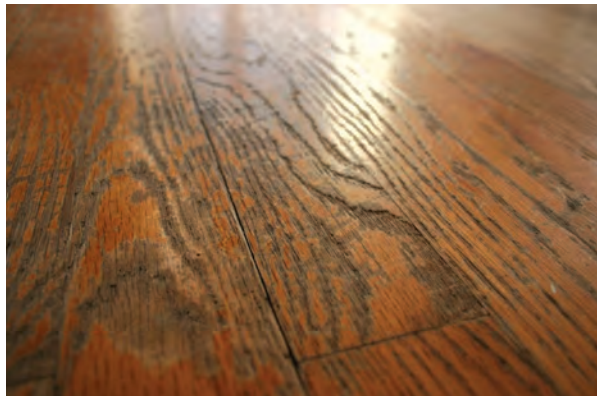
Dishout/Shellout

DEFINITION: Undulations in the surface of individual boards or within the wood floor, resulting from softer areas having been worn, hollowed, or sanded to a lower level than harder adjacent areas.

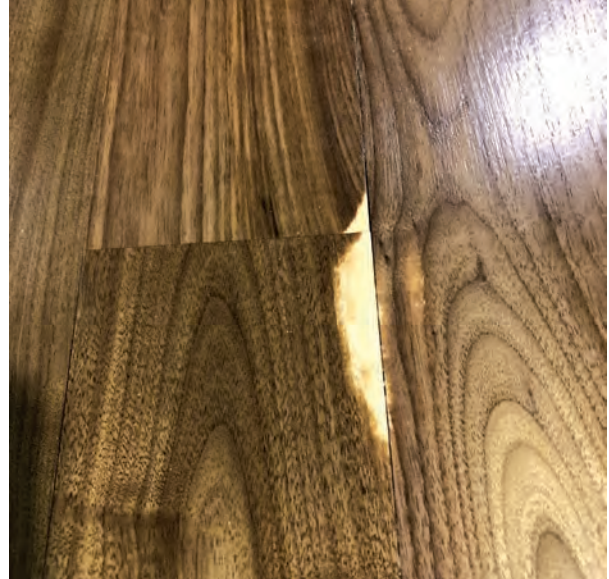
Veneer Sand-Through

DEFINITION: The top/wear layer veneer (lamina) of engineered flooring has been completely sanded through to the core layer.

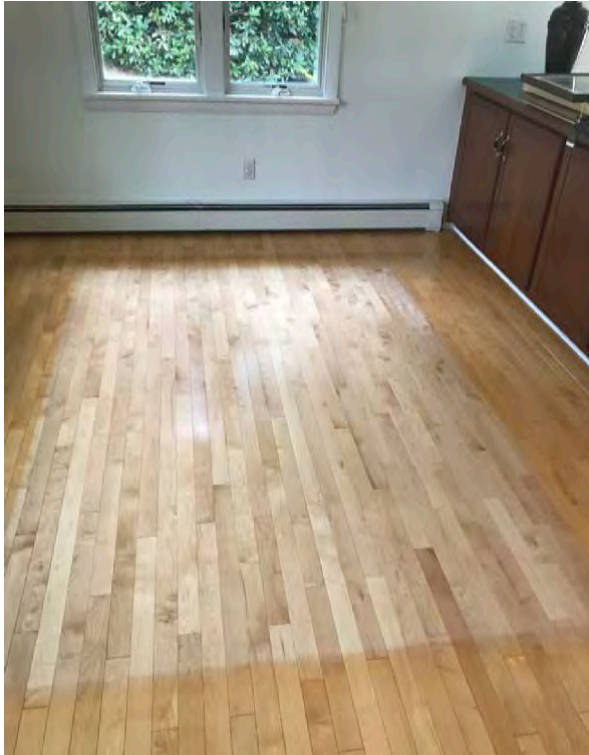
Finish/Colorant Discoloration

DEFINITION: The finish or colorant systems changes color.

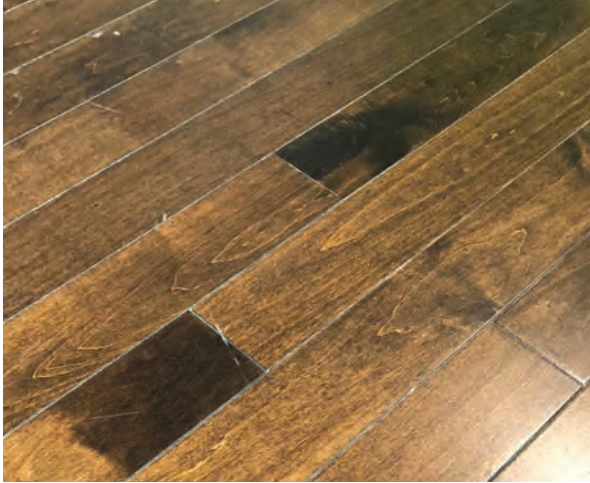
Blotchy Stain/Colorant

DEFINITION: The appearance of an inconsistent stain or colorant from one area of a finished floor to another. Stained/colored floors should be uniform in color. Color tones may vary from board to board or within individual boards due to natural variances within the wood.

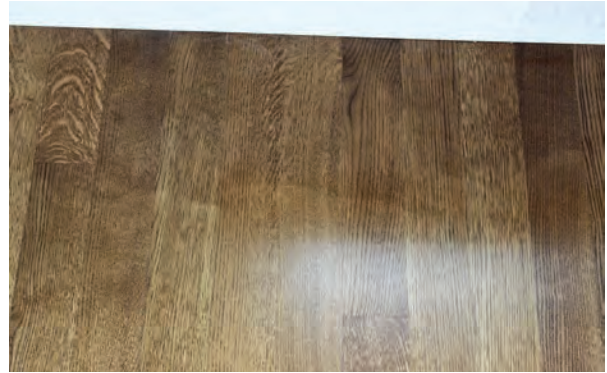
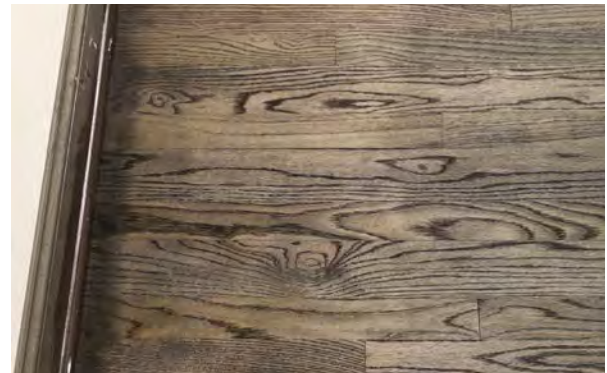
Picture Framing/Halo

DEFINITION: The edges of the room appear to be a slightly different color than the rest of the room.

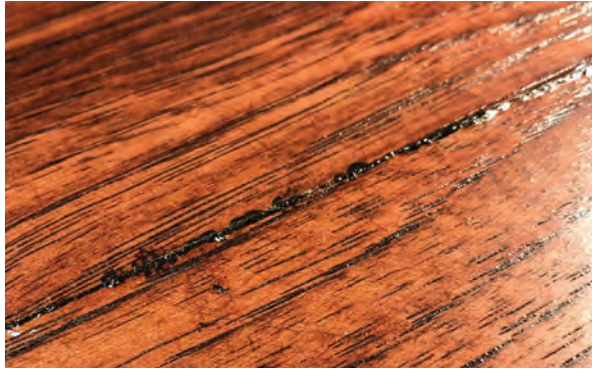
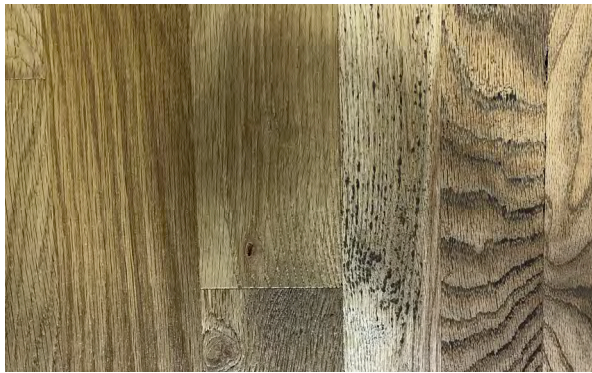
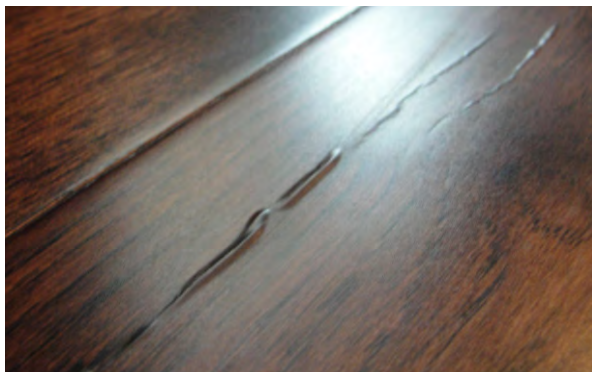
Stain Bleed Back

DEFINITION: A staining phenomenon occurring after the initial application of the stain, where the stain seeps back to the surface of the wood. This may happen at board seams, with open-grain species, tight grain, knots, or burls.

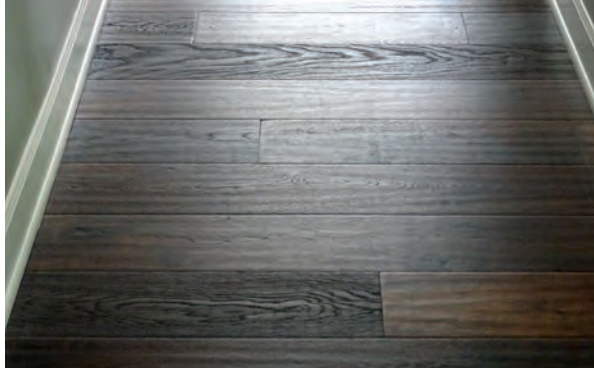
Finish Film-Thickness Discrepancy

DEFINITION: A discrepancy in the depth of the film of finish applied to a wood floor. Mil/film thickness of finish can be evaluated, but should not determine acceptability.

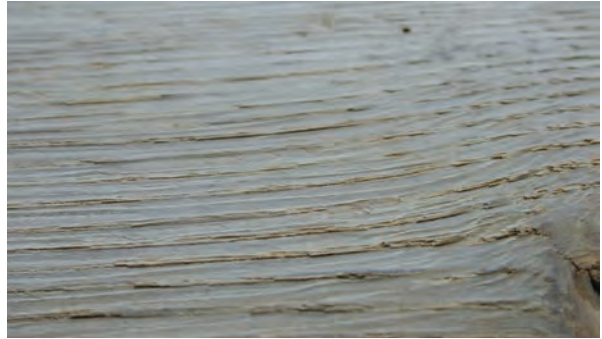
Roughness/Grain-Raise

DEFINITION: The surface of the wood floor feels rough to the touch.

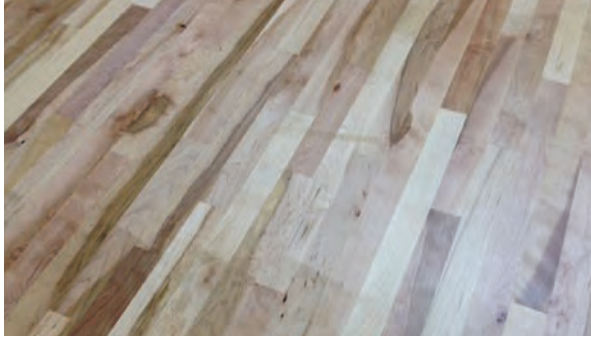
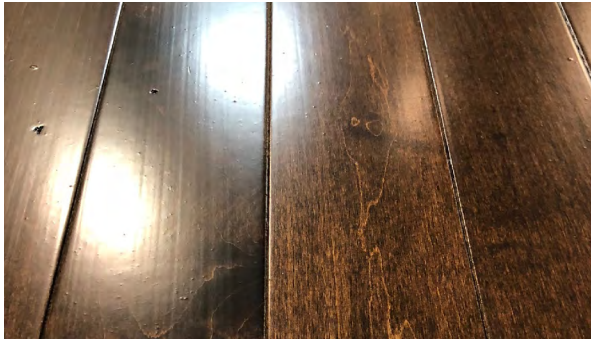
Applicator/Finish Streaks

DEFINITION: Visible ridges, lines, or marks left on the wood floor, representing the application tool used from any stage of the finishing process.

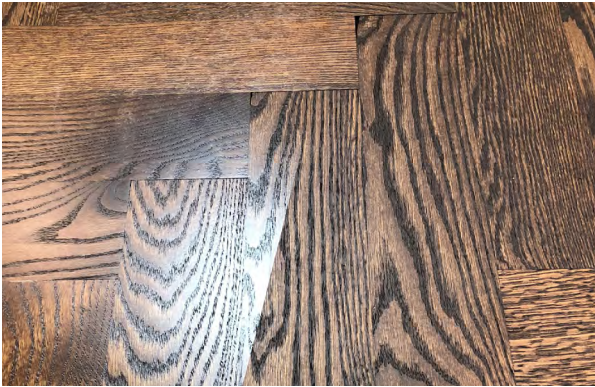
Holidays/Skips

DEFINITION: An exposed area of uncoated wood or the undercoating, when the intention was to coat the entire area.

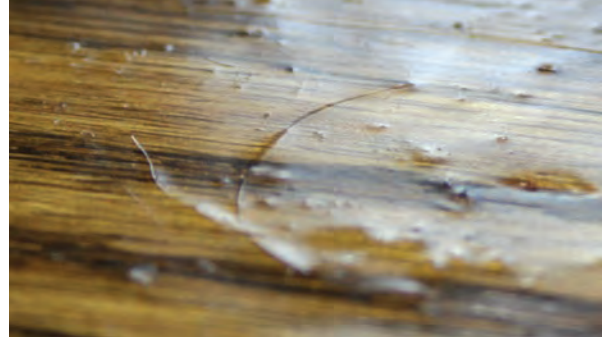
Debris in Finish

DEFINITION: A raised bump in the film of finish often consisting of dust, hair, applicator fibers, foreign contaminants, solid finish particles, or other artifacts. Due to the nature of most coating environments, minimal amounts of debris within reason can be expected in any coat of finish.

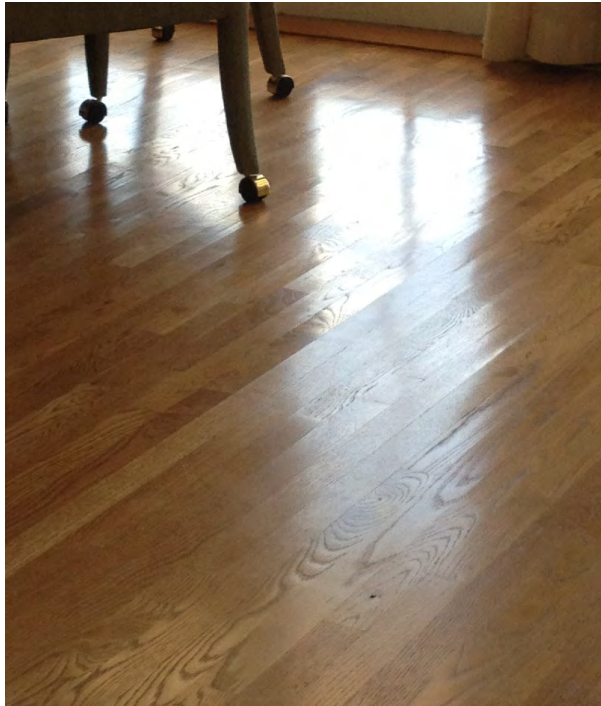
Uneven Sheen/Gloss Levels

DEFINITION: The sheen or gloss level of the final coat of finish varies from one area of the floor to another. As film-forming finish products decrease in gloss, they increase in amounts of matting agents. Lower sheen products have the most matting agent, and thus, can more-easily manifest uneven sheen levels. Sheen/gloss levels should not be assessed until all final coats have been applied and are fully cured.

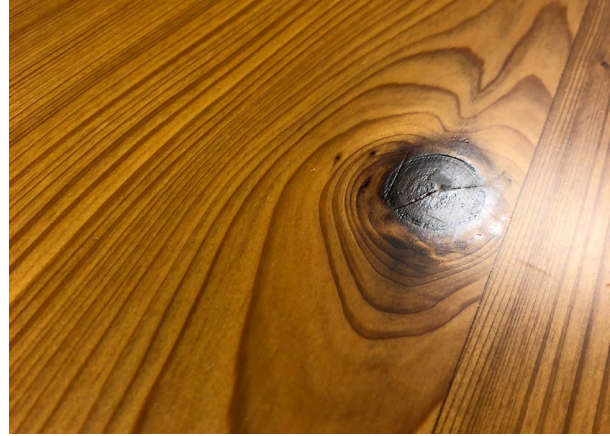
Sticky Board Syndrome

DEFINITION: Wood floor finishes that do not dry, adhere, cure properly, or appear the same on specific areas of a board or individual boards.

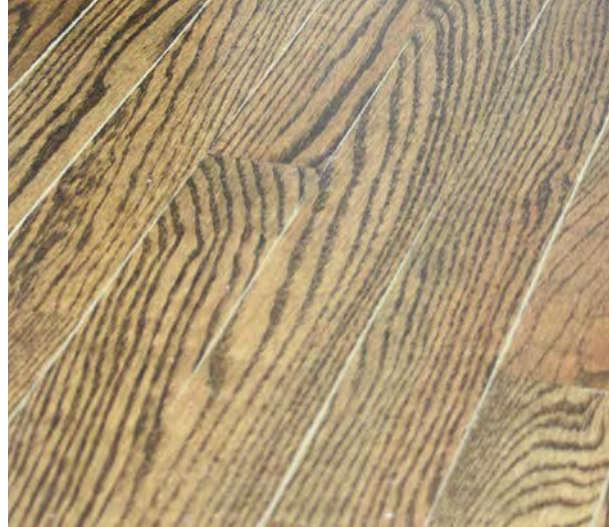
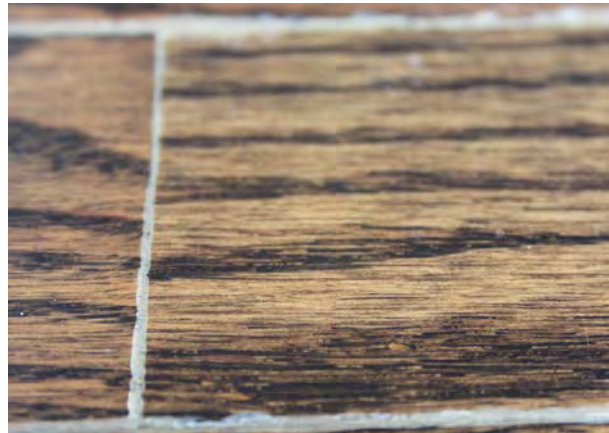
White Lines

DEFINITION: White lines appear between board edges of site-applied film-finishes.

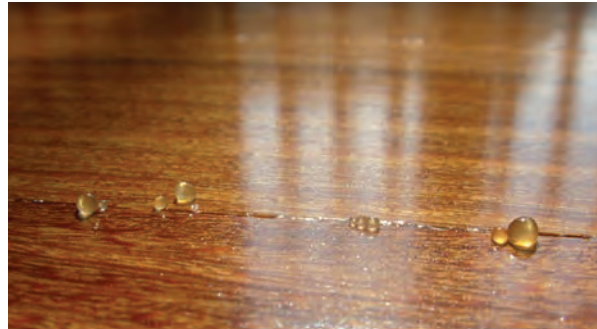
Poly Beads

DEFINITION: Small round balls that appear as beads, or “BBs” of finish, that form along the joints of the individual boards. They can be soft and sticky when first formed, and will become hard if left undisturbed. When these wet beads are stepped on, they can become unsightly smears along board edges.

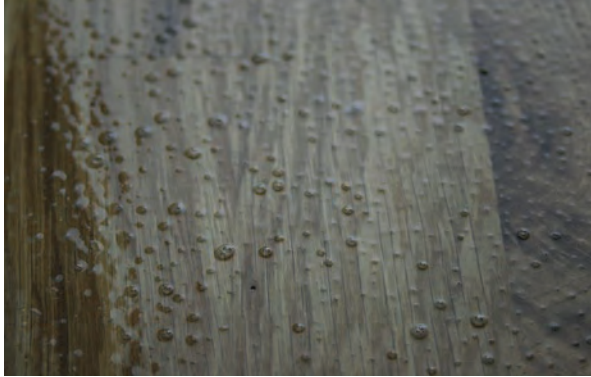
Bubbles

DEFINITION: Raised bumps, or air-filled bubbles visible in the film of the finish. These include both full bubbles and bubbles that have popped.
