PROBLEMS, CAUSES, AND CURES

Technical Publication No. C200 • Revised © 2018 | 3rd Edition

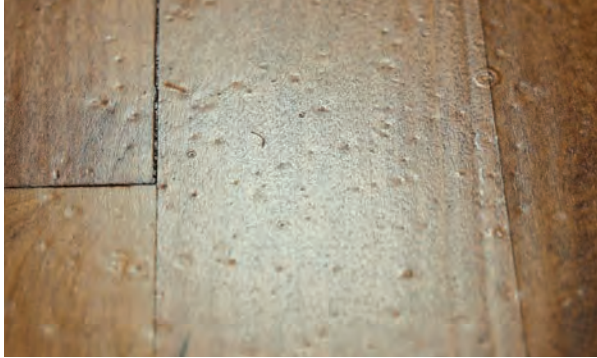
Pin Holes

DEFINITION: A visible finish imperfection where the surface of the finish film recedes from a very small area or areas of the surface.

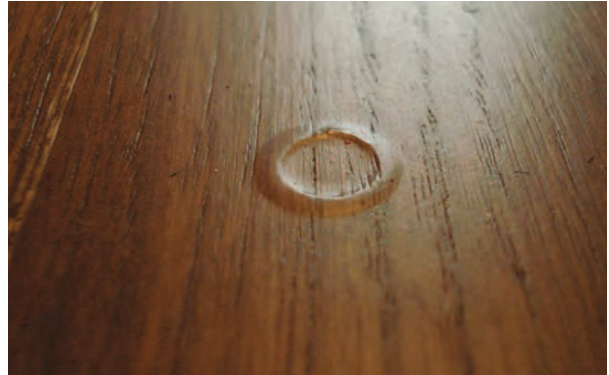
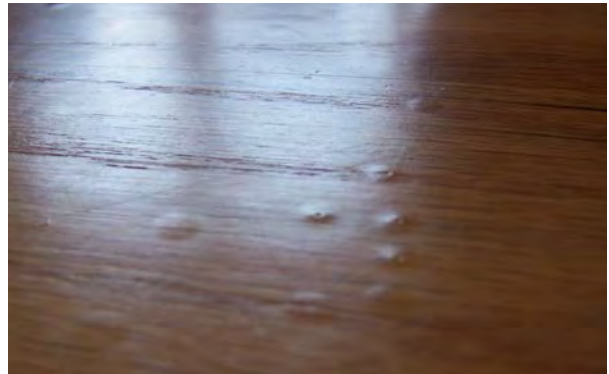
Craters/Fisheyes

DEFINITION: A visible finish imperfection that manifests by the crawling of wet finish film into a single area or pattern resembling small dimples or bowl-shaped depressions, sometimes accompanied by a particle in the center.

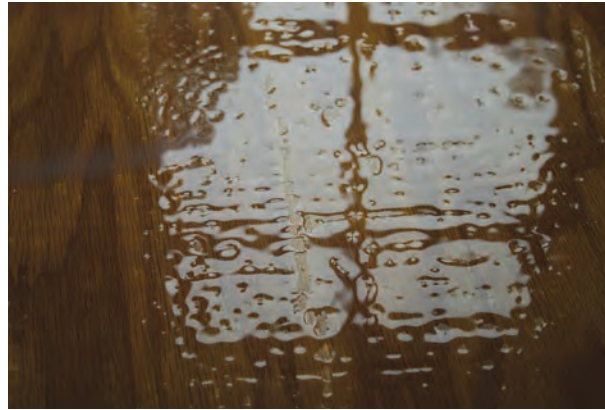
Crawling

DEFINITION: A visible finish imperfection where the finish film is repelled from areas of the surface, leaving the appearance of thin or uncoated affected areas. May be very long and oval shaped, and may vary in size.

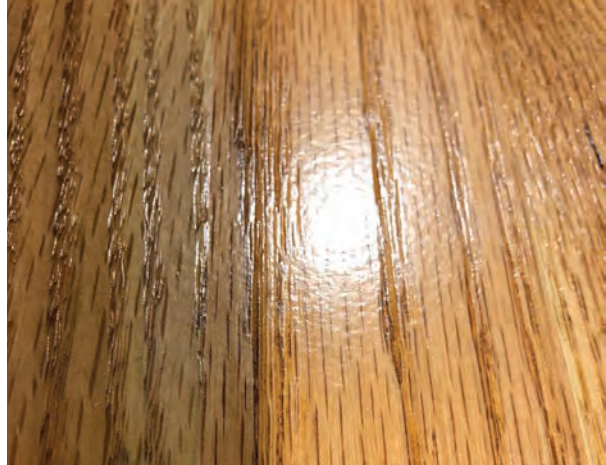
Orange Peel

DEFINITION: A visible finish imperfection where the surface of the dry finish film exhibits a flaw that resembles the texture of an orange peel.

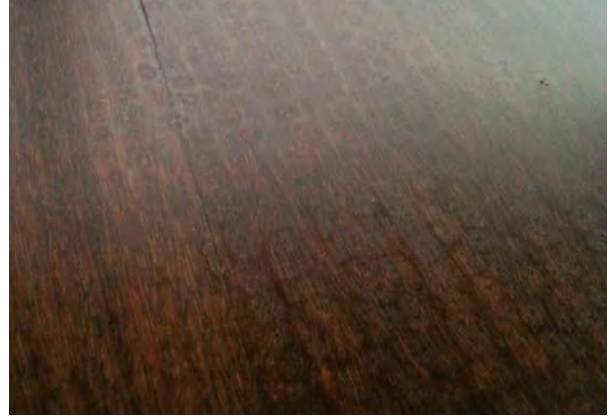
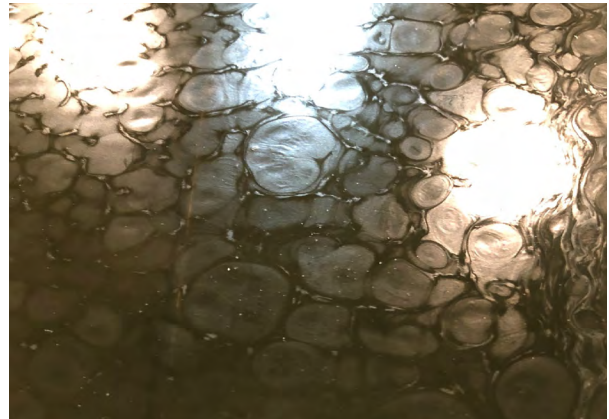
Benard Cells

DEFINITION: A visible finish imperfection resembling a pattern in the smooth finish film that resembles a clustering of "cells." They typically appear as less-glossy, often round, curvy, or geometrical (hexagonal, pentagonal) in shape, and may range in size from very small, up to 1". Benard cells are more common with lower sheen or pigmented finishes.

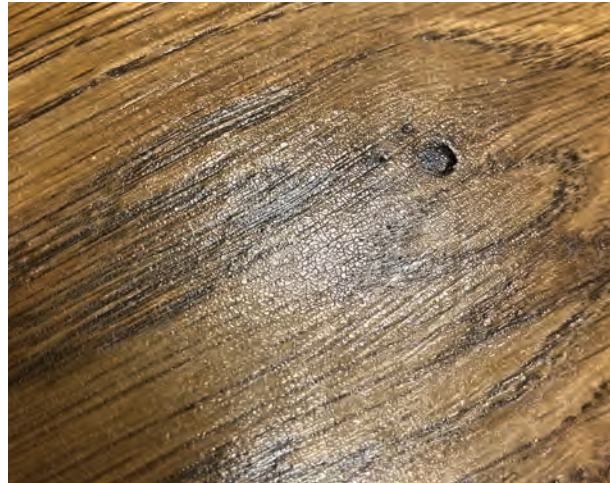
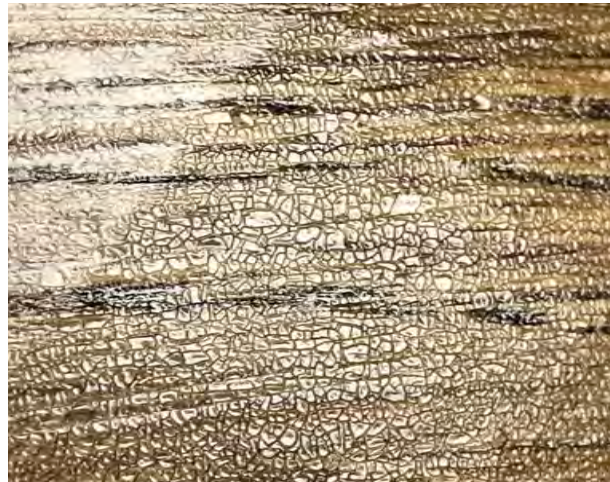
Crazing/Alligatoring

DEFINITION: A visible finish imperfection that appears as a network of very small, fine cracks or fissures in the surface of the finish film, which sometimes resembles the skin of an alligator or crocodile.

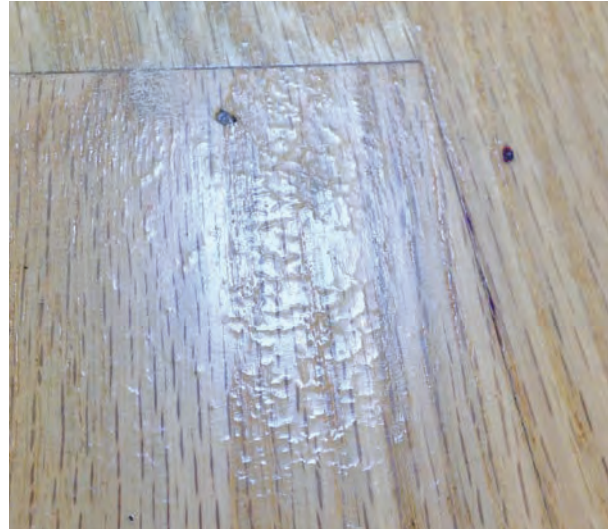
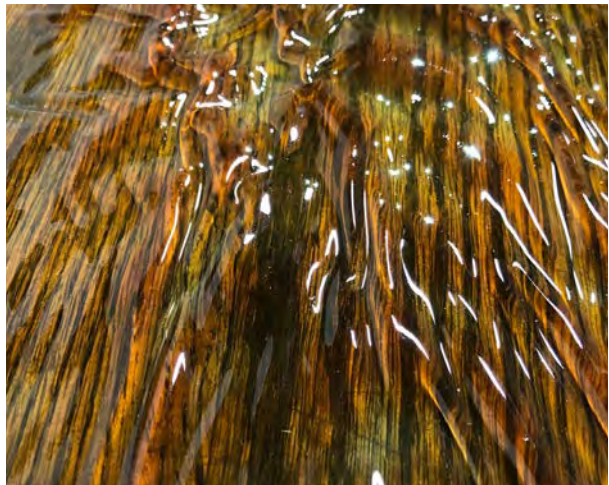
DEFINITION: A visible film-finish imperfection that appears as the skin of a dried prune. Wrinkling may happen with all types of film-finish, but is most common with oil-based urethanes.

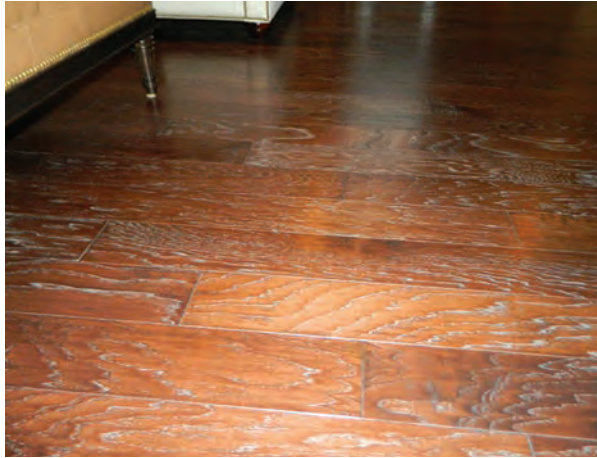
Open-Grain Contamination

DEFINITION: An accumulation of contaminants in open voids or characters, such as in textured wood, the soft grain/springwood, open knots, splits/checks, etc., on the surface of the installed floor.

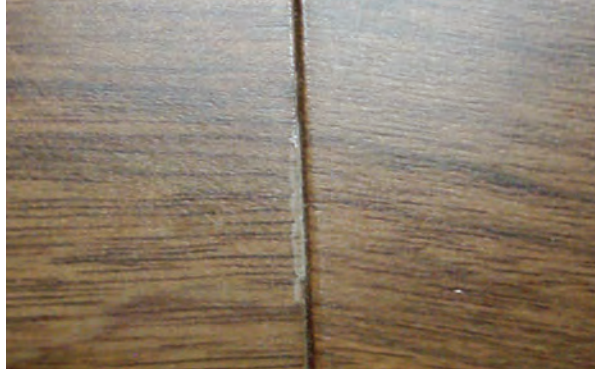
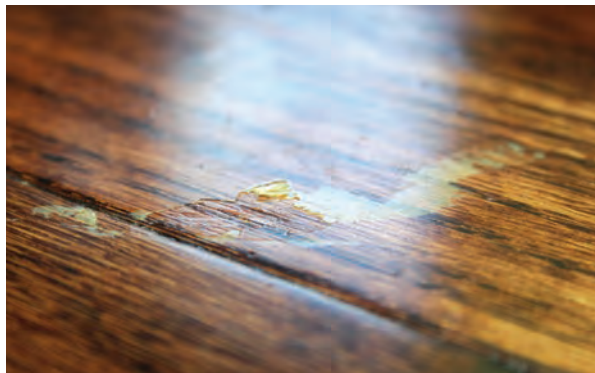
DEFINITION: The loss of film-finish adhesion to the flooring surface or between coating layers.

Chipping/Flaking Finish - The condition that occurs when a dried film of finish separates from the previously applied finish in the form of chips or flakes.

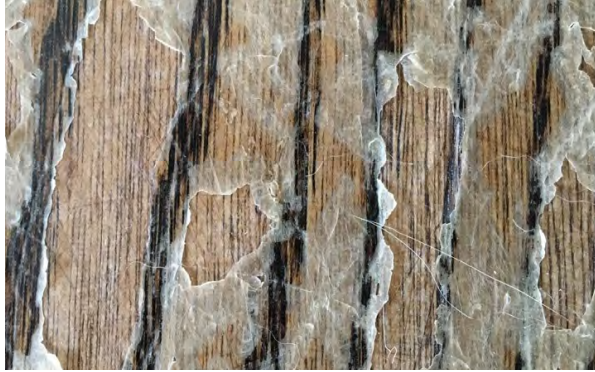
Finish Adhesion Failure

Peeling Finish - The condition that occurs when a dried film of finish separates from the underneath surface in the form of large pieces or sheets.

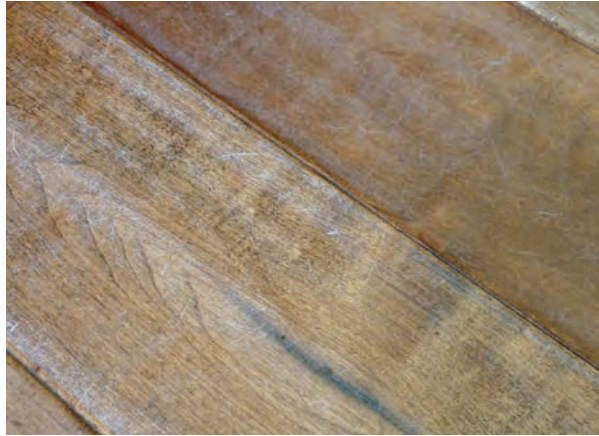
Finish Wear Discrepancies

DEFINITION: The performance of the surface coat of finish not meeting expectations.

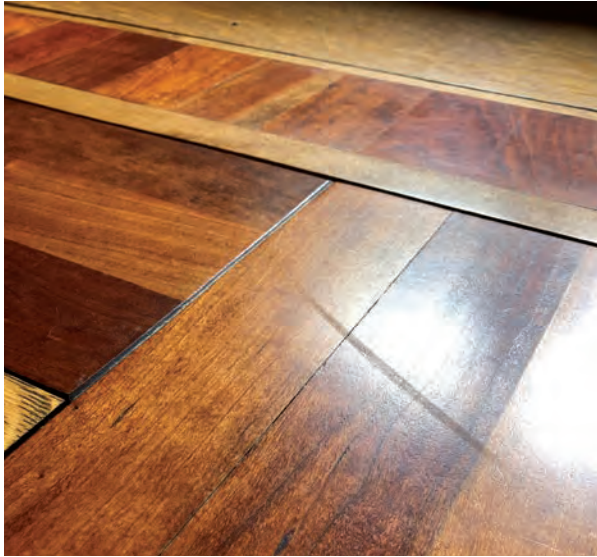
Scuffing

DEFINITION: Marks or abrasions left on a wood floor surface or finish.

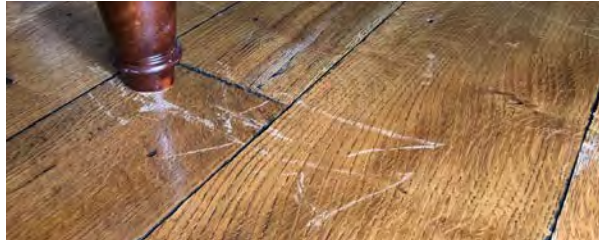
- **Scratches** - caused by applied horizontal and vertical forces.

- Finish systems may be marred or scuffed, either from chemicals or from heat generated by sliding objects across them. These may look like scratches, but are not.
- Surface scratches are typically only in the finish coats. A fingernail can't feel the ridge.
- Deep scratches are typically through the finish coats and have torn the wood fibers.
- Cross-grain scratches are deep scratches, and are oriented perpendicular to the direction of the flooring, often crossing multiple board widths and have a higher probability of exhibiting wood fiber tear. Deep scratches, usually termed "gouges," are typically through the finish coats and have torn the wood fibers.
- As scratch damage increases in severity, so does the likelihood that the damage will also include denting.
- **Indentations** - notches, grooves or depressions on the surface of the flooring.

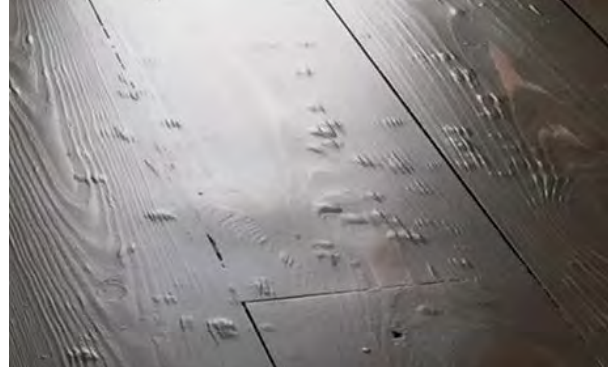
- **Wood bruises** - from a previous force or trauma to the surface of the boards that is not normally noticeable during the installation or handling of the product. This damage can become exposed with an increase in moisture, such as with the introduction of water through water-popping, water-based finishes, water-based stains, or similar reactive conditioners.

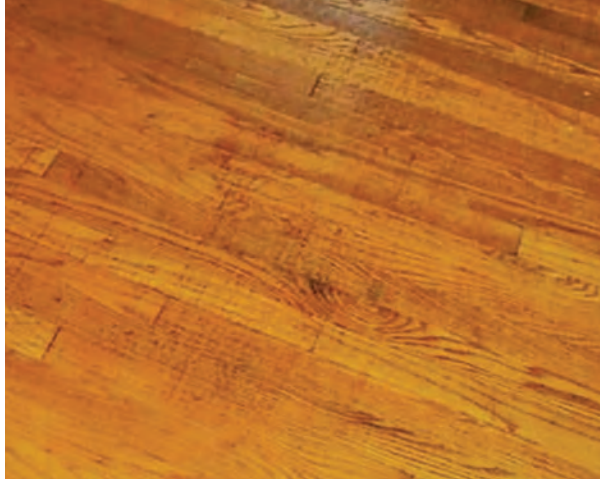
Surface Impressions

DEFINITION: A shape or pattern imprinted on the face of the board, which resembles an item or object that had been in direct contact with it.

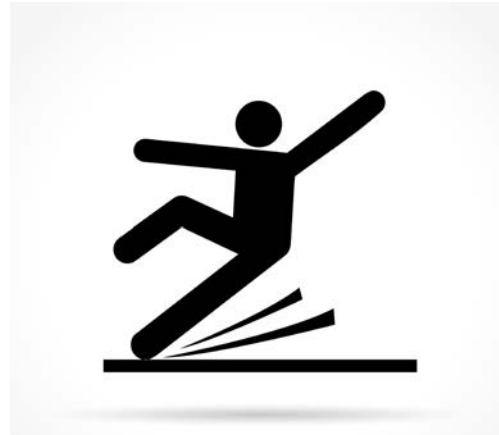
Slippery Floors

DEFINITION: The perception that the floor feels slippery. All wood floor finishes could be considered slippery with normal use. Most wood floor finishes are not usually considered to be slip-resistant, and some wood floor finishes feel slipperier than others.
